# Arboricultural Appraisal Report

Impact Assessment & Method Statement to Inform Development

Land to the Southwest of Leavedale Road,  
Penkridge  
Staffordshire  
ST19 5AT

CLIENT:	DLP Planning Ltd
MWA REF:	DEV220425-937 Rev01
MWA CONSULTANT:	Mark Bisley <small>BSc Hons</small>
REPORT DATE:	19/07/2023

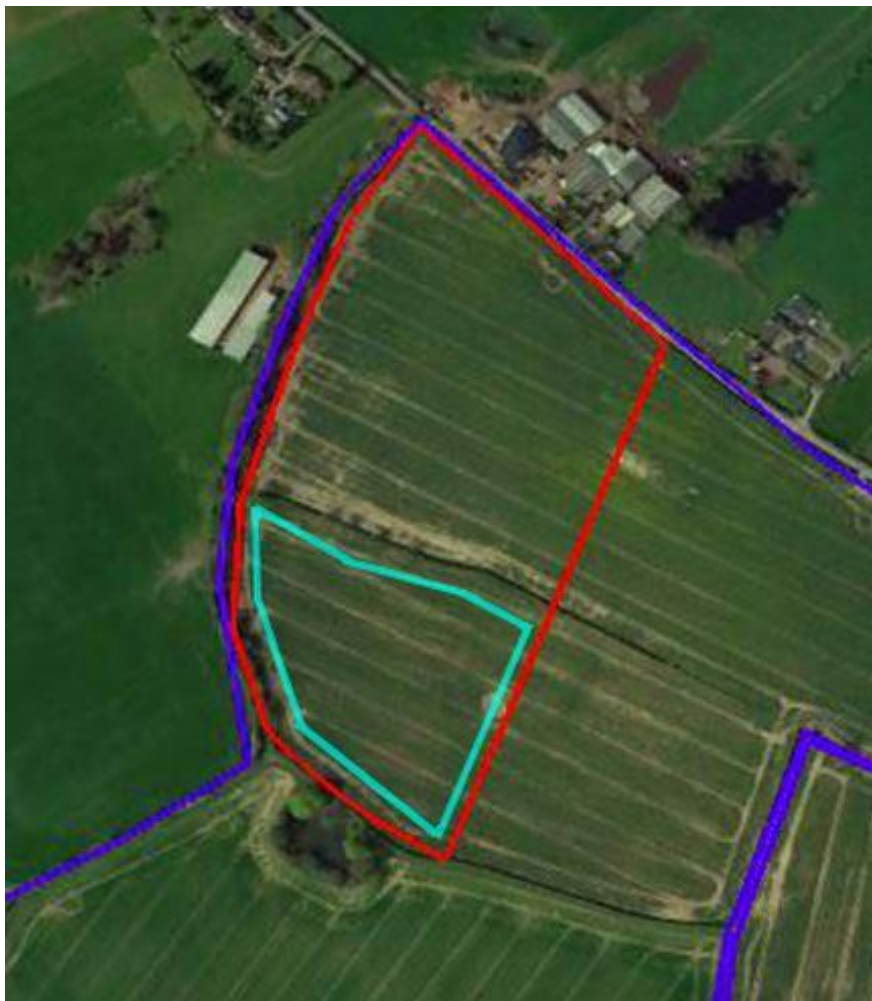
**Figure 1: Existing Situation**

- 6.1 The site is located to the southwest of Leavedale Road in a largely agricultural area. The site is composed of two arable fields with filed boundary hedgerows and standard trees on the boundaries. The western boundary is the most heavily wooded, having an almost continuous line of trees along its length.
- 6.2 The remaining boundaries have few or no trees, with the hedges forming dense, low-level screens between fields.
- 6.3 The largest field is in the northern part of the site and is largely open in views from other fields to the east, while the smaller, southern filed is bounded by hedges on all sides.

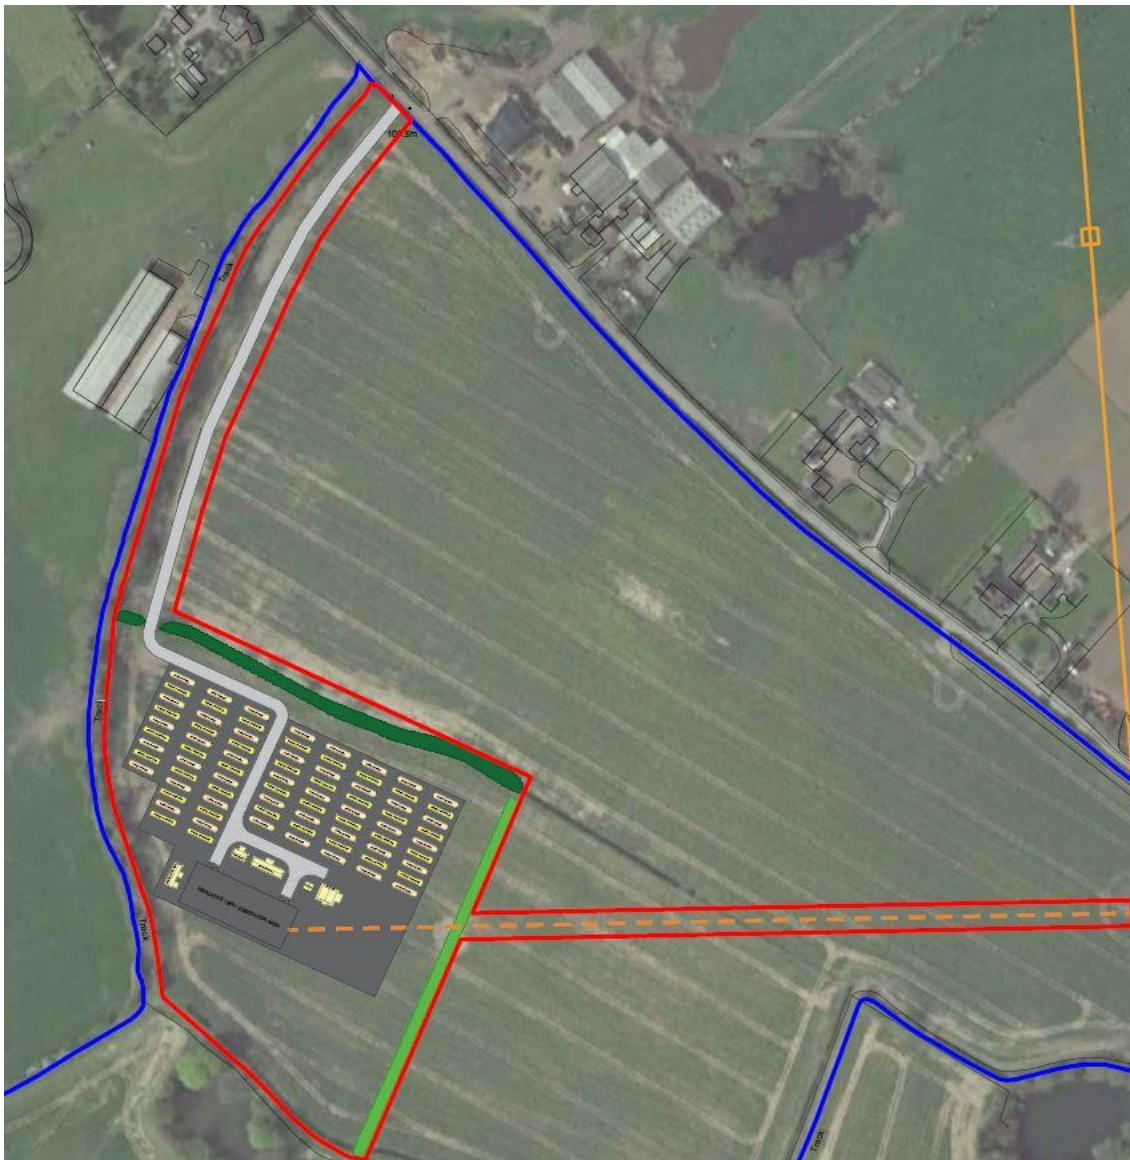
**Figure 2: Proposed Situation**

- 7.1 The proposed development will entail the construction of a 49.9MW Battery Storage Scheme in the southern field, with an access road through the northern field adjacent to the western boundary.
